**Re: Minor Individual Permit; SIC 1221; NPDES Compliance Evaluation Inspection; CMI / Ancho-Gachupin-Bracket Mine; NM0030180; July 19, 2017**

## NPDES Compliance Inspection Report

| <b>Chevron Mining, Inc. - Ancho-Gachupin-Bracket Mine - 07/19/2017</b> | <b>PERMIT NO. NM0030180</b> |

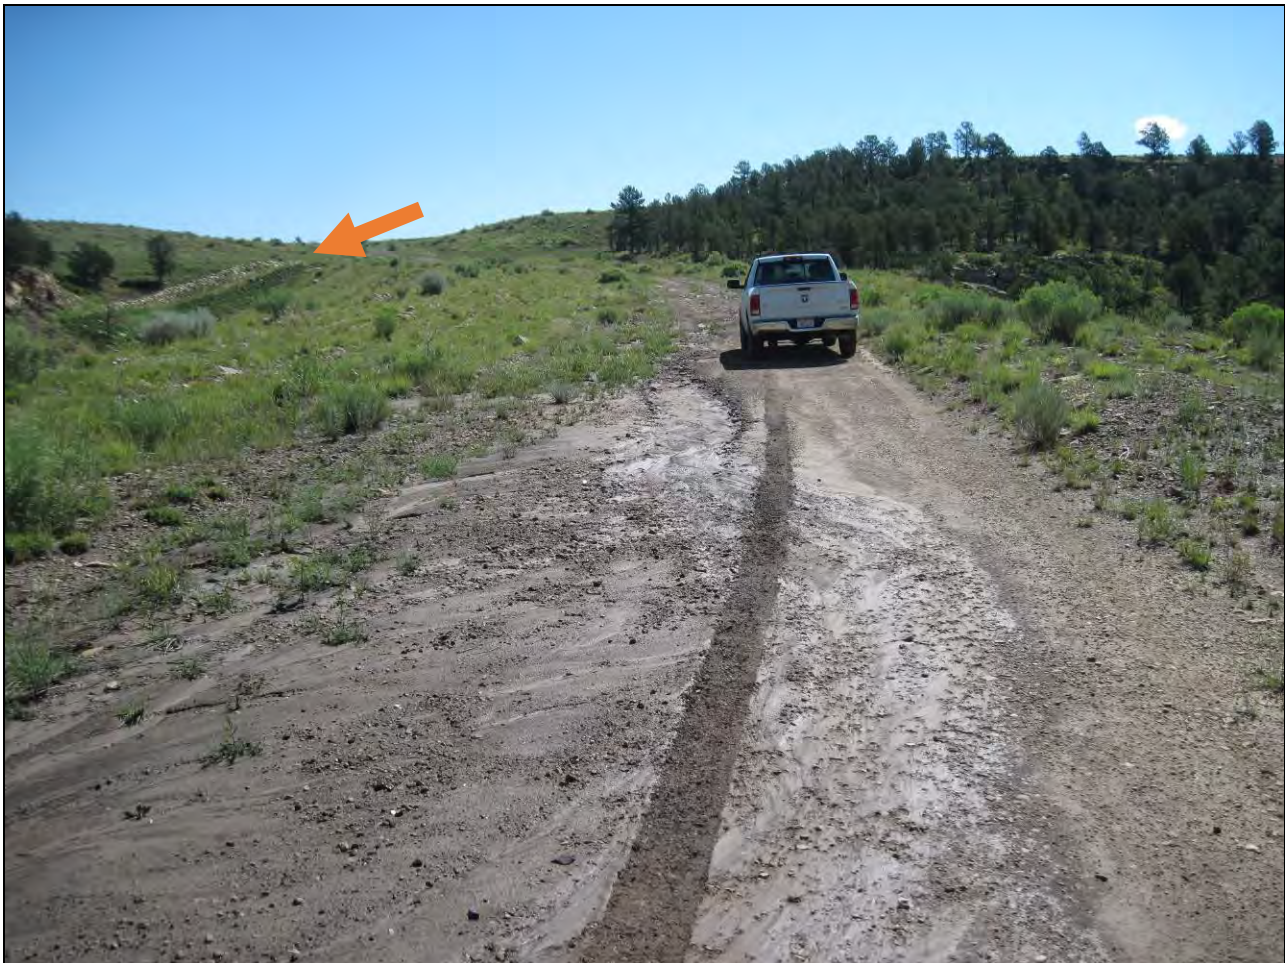
Location: Chevron Mining, Inc., Ancho Mine, et. al, NM0030180, South of Outfall 004

Subject: South of the monitoring location for Outfall 004, looking generally east from an access road toward a reclamation area in the background of the photo. Photo shows wet soils and shallow erosion features (rills and sheetflow) from the location of a former haul road that is now a shared access road according to the on-site representative. Coal was observed on the access road. There was no observed discharge from the access road to a rock lined conveyance below the monitoring location for Outfall 004 on the day of this CEI. Arrow points to a diversion ditch that is intended to direct or convey runoff from the reclamation area to the pond associated with Outfall 004. No recent evidence of flow from the diversion ditch onto the access road was observed on the day of this CEI.

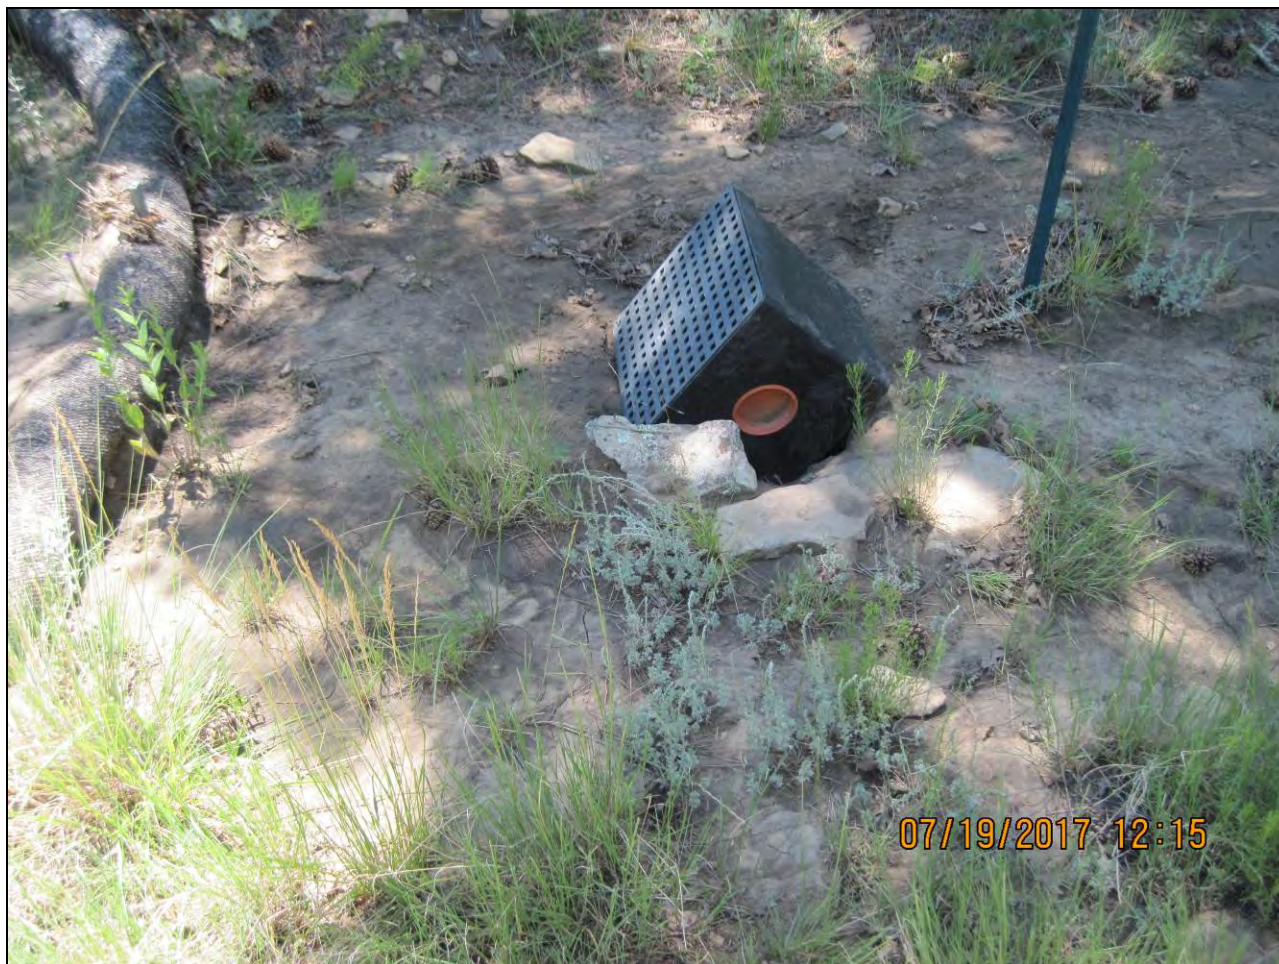
**NMED/SWQB  
Official Photograph Log  
Photo # 2**

Location: Chevron Mining, Inc., Ancho Mine, et. al, NM0030180, Monitoring Location for Outfall 002

Subject: Sample collection box is not flush with the ground surface. It was not apparent that sufficient flow in the shallow channel would enter the box.

- A review of monitoring equipment effectiveness appears needed. Maintenance, repair or alternative sample collection appears needed at Outfall 022 (see Photos #2 and #3).

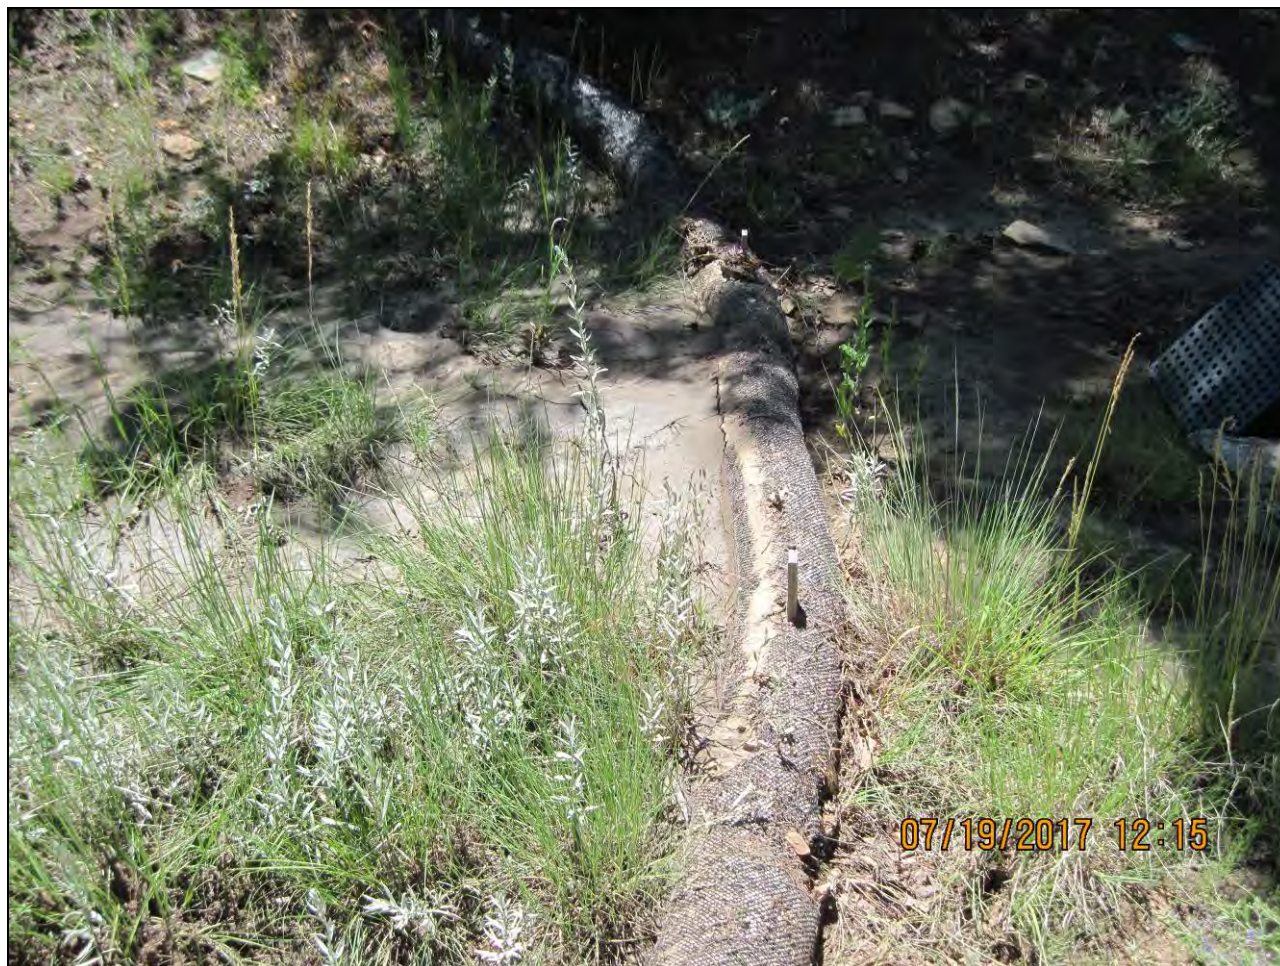
**NMED/SWQB  
Official Photograph Log  
Photo # 3**

Location: Chevron Mining, Inc., Ancho Mine, et. al, NM0030180, Monitoring Location for Outfall 022

Subject: Straw wattle above the sample collection box shown in the previous photo had accumulated sediment. Purpose of the straw wattle or how the measure may direct flow into the sample collection box was not apparent.
